# HOME INSPECTION REPORT

57 Avon Ave  
Toronto

Prepared by: Bob Papadopoulos P.Eng., RHI \*

Inspection Date: [July 29 2026](#)

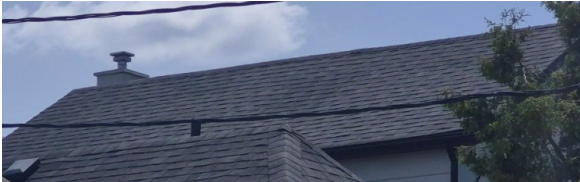
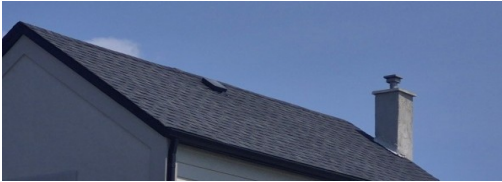
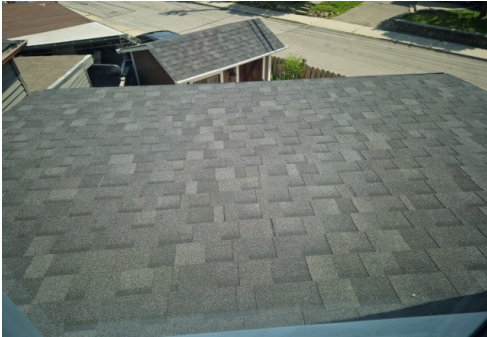
| <p>Sloped Surface: <a href="#">overall surface in good repair</a></p> <p>Porch(s): <a href="#">overall surface in good repair</a></p> <div style="display: flex; justify-content: space-around;"> </div> <div style="text-align: center;"> </div> <p>East Slope: <a href="#">overall surface in good repair</a></p> <div style="text-align: center;"> </div> | | | | |

| <p>Note: <a href="#">Recommend Annual Maintenance Contract for Roof Surface, Flashing Details and Chimney(s)</a></p> | | | | |

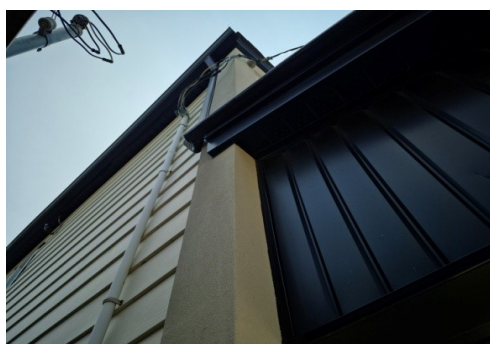
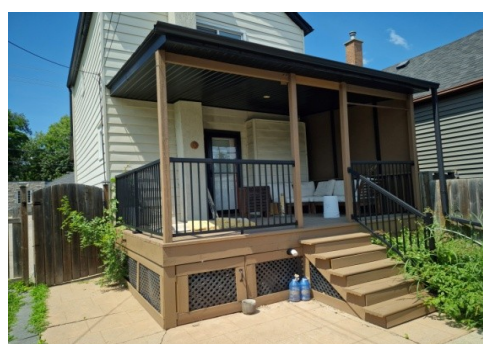
WALL SURFACES: overall in good repair  
DOORS/WINDOWS: overall in good repair

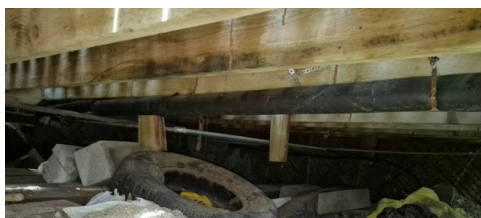
STRUCTURES overall in good repair  
DECK overall in good repair, monitor for sagging and install central supports if required

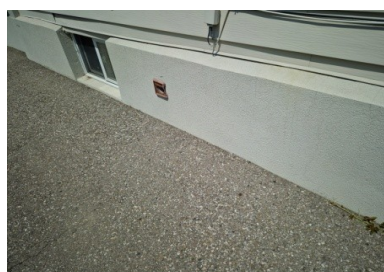
\*\*Walk(s)/Driveway(s): overall in good repair  
seal gap along wall

Note: Maintain Gutters & Downspouts annually. Extend Downspouts at least 6-feet away from the house

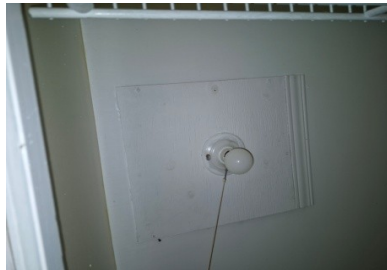
ROOF: access sealed (also ceiling light obstruction)

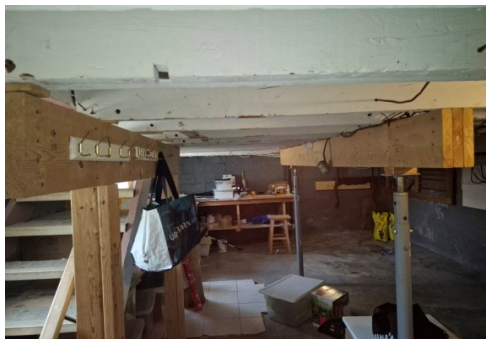
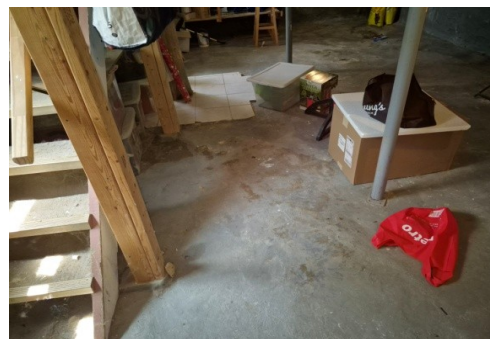
FLOORS: basement: main floor joists (basement stair opening) have been shore dup with beams and posts, posts should be on proper footings thought overall functional, continue o monitor, if renovating basement will require proper installation, also beam should be properly secured to joists and posts properly secured to floor

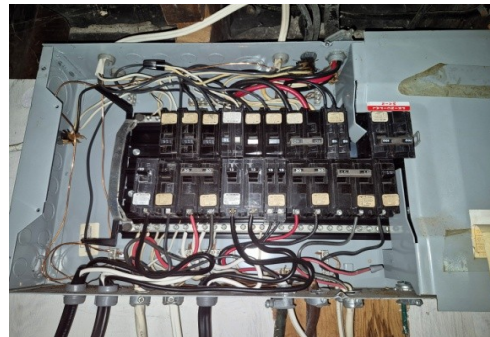
SERVICE ENTRANCE: overall in good repair  
SERVICE PANEL: overall in good repair

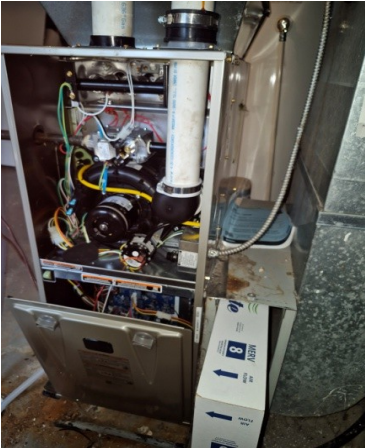
| <p>FORCED AIR FURNACE: service annually</p> <p>Filter: replace 1-per-6 to 12 months</p> | | | |

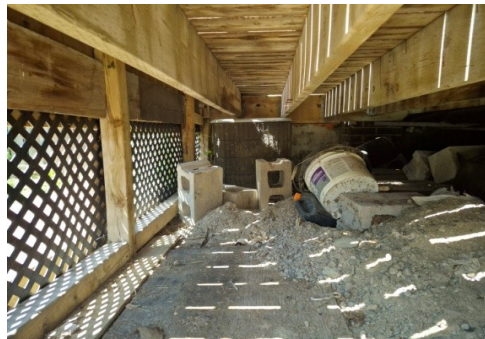
**Observations/Recommendations**AIR CONDITIONER: [service annually](#)Outdoor Coil: [poor access under deck, requires service/cleaning](#)

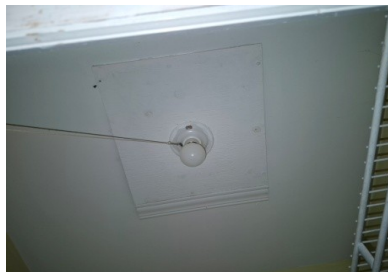
ROOF SPACE: access sealed (also ceiling light obstruction)
